Alaska Railroad Corporation P.O. Box 107500 • Anchorage, Alaska 99510-7500 (907) 265-2300 • Reservations • (907) 265-2494 TTY/TDD • (907) 265-2620 www.AlaskaRailroad.com

Timber Trestle Bridges in Alaska Railroad History

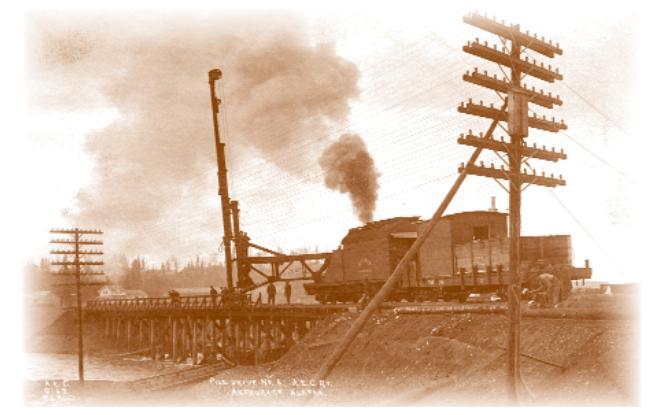
Alaska Engineering Commission crews employ a steam-driven pile driver to construct the bridge over Ship Creek. (ARRC photo archive)

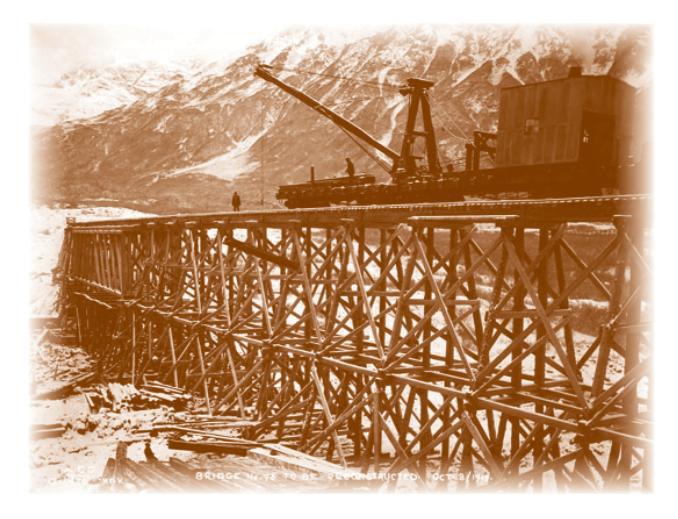
While some timber trestle bridges — such as the bridge at mile 75 that was reconstructed in 1919 — are tall and elaborate...

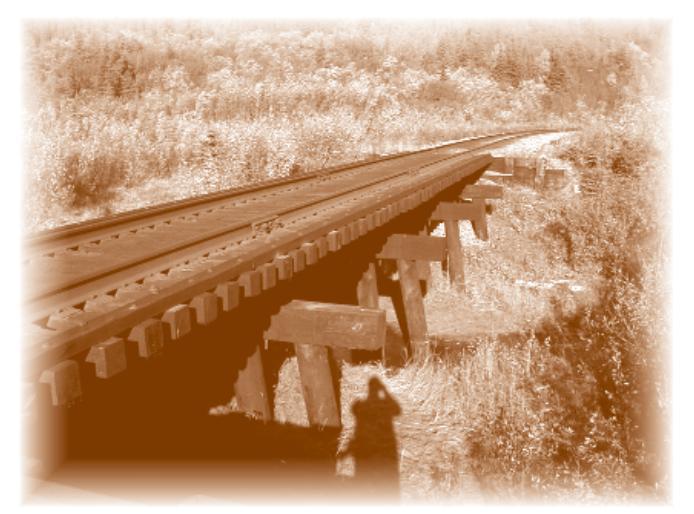
... Most timber trestle bridges are simpe, utilitarian structures — such as this bridge at mile 335.8 (ARRC photo archive)

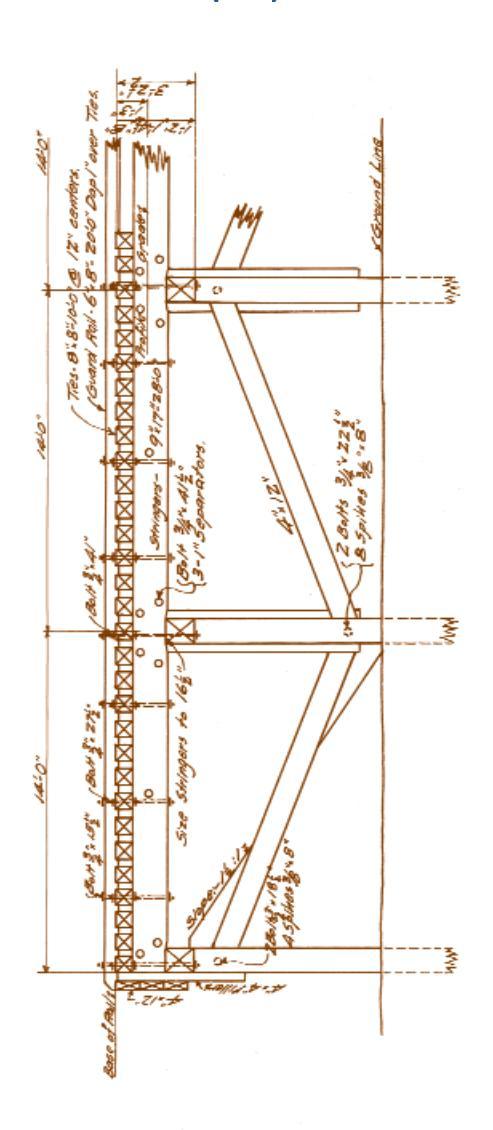
> DEPARTMENT OF THE INTERIOR. ALASKAN ENGINEERING COMMISSION. STANDARD PILE TRESTLE. SIDE ELEVATION - HEIGHTS IDFT. +LESS. Scale - f " 10" Ship Creek, Alasha April 1915 Chairman.

Alaska Engineering Commission 1915 engineering drawings for a standard pile trestle bridge.

TYPICAL SIDE ELEVATION OF TRESTLE HEIGHTS TOP OF CAP TO GROUND IDFT OR LESS Notes:- All piles to be sized to 12" at Intersections of brazes, All longitudinal brazes to be on track piles.

Early ARR timber trestles were constructed with 14- to 15-foot spans in accordance with *General Specifications for Piling for Trestle Bridges* as approved by the AEC on May 25, 1915. Span length was limited by the load bearing strength of timber stringers. To minimize costs, many spans were built using green native timber and were held together with spikes rather than bolts (Wilson 1977). Specifications called for the use of spruce trees with the bark removed to make piling for all timber trestle bridges: "All piling shall be cut from sound live trees of slow growth, firm grain, free from shakes, decay, large unsound knots, or other defects that will impair their strength and durability" (AEC, 1915). Timber trestle bridges built to these standards no longer exist.

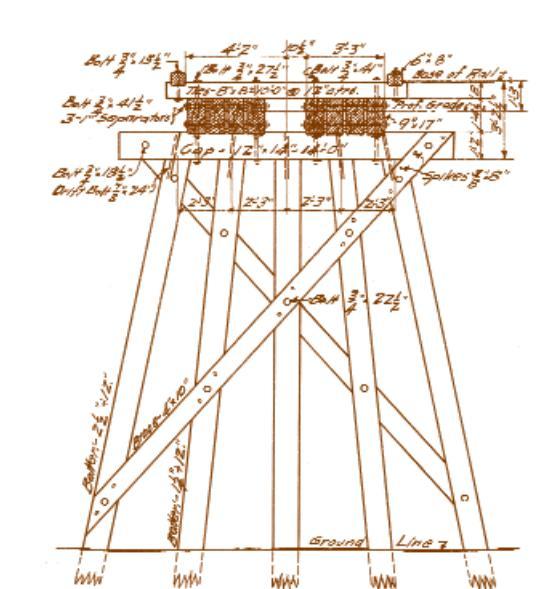
DEPARTMENT OF THE INTERIOR ALASKAN ENGINEERING COMMISSION. STANDARD PILE TRESTLE. INTERMEDIATE BENT.

TYPICAL ELEVATION INTERMEDIATE BENT.

Notes: All piles in each best to be striven by sovinging pile sinver leads and conter lines of piles to meet of a point 2014 " othere top of ago. Trestle bants below 70" in height from ground to top of ago need neither transverse nor lengivalinal bracing. Between 70" and 12-0" only transverse bracing, and above 12-0" both transverse and lengi-tudied transverse tudinal bracing Loading - Looper's E-50.

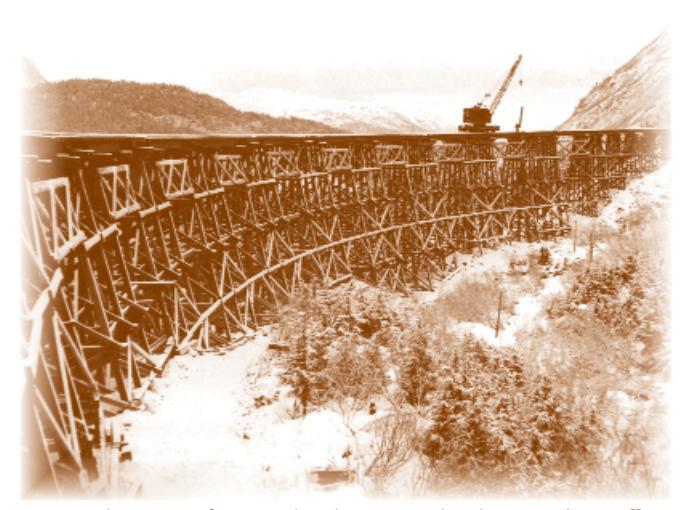
During the winter of 1948, railroad crews conduct brace work to stiffen the Loop District trestle at mile 48.3. in order to ensure continued safe operation. (ARRC photo archive)

The Loop District...

high trestles were built in the Placer River canyon at miles 48 and 50 as alternatives to costly hillside and tunnel work. One was an incredible four-story loop that crossed over itself and looked like a donut from the air.

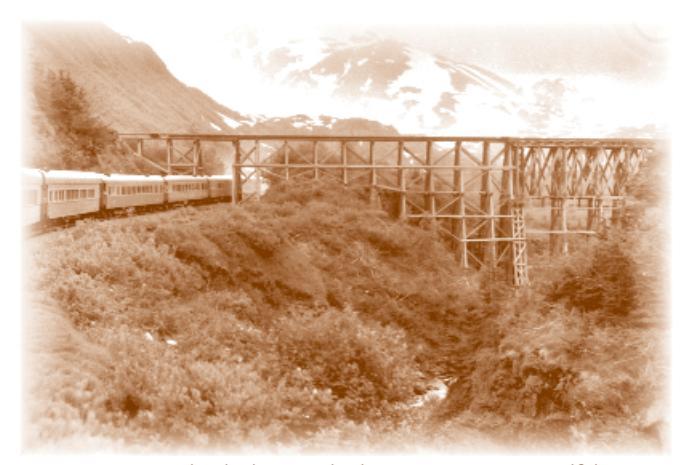
A train goes under the loop track where it crosses over itself during the summer of 1950. (ARRC photo archive)

Most timber trestle bridges were very simple structures, however, the former trestle constructed in an area known as the "Loop District" was a remarkable exception. In order for the railroad to climb the Kenai Mountains at a reasonable gradient, "high timber trestles were built in the Placer River canyon at miles 48 and 50 as alternatives to costly hillside and tunnel work. One was an incredible four-story loop that crossed over itself and looked like a donut from the air" (Wilson 1977).

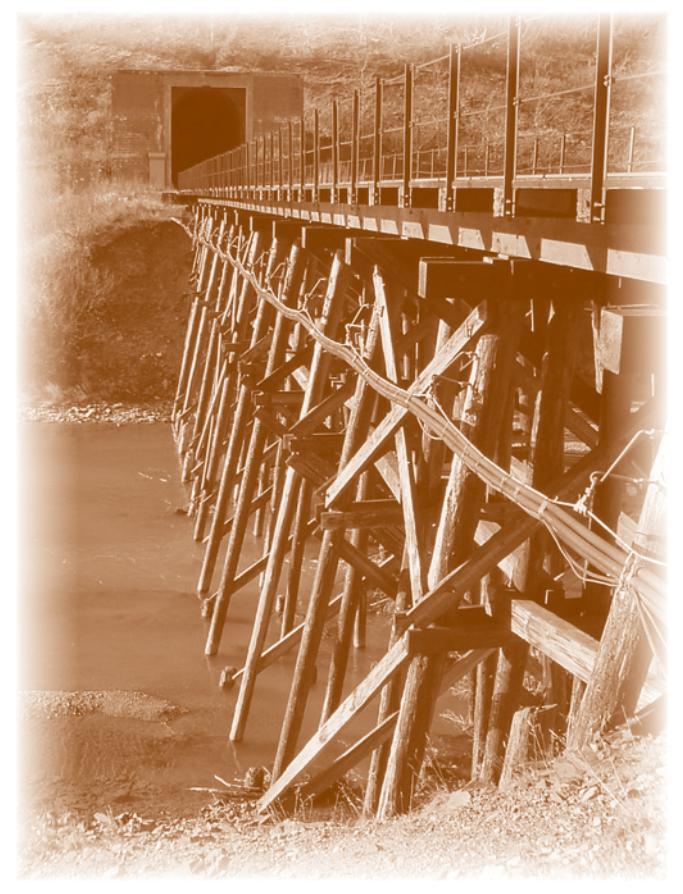
Timber trestle bridge at mile F5.7 on the Whittier Branch. (ARRC photos)

Further improvement came in anticipation of World War II. In the late 1930s, the military began building Fort Richardson, adjacent to Anchorage. Troops also helped ARR to expand and maintain a rail connection to Whittier, an ice-free port deemed vital to Alaska's defense. Two tunnels were drilled and five timber trestles erected along the 12.4-mile Whittier Branch. Among them was a notable bridge at branch mile F5.7. Constructed in 1942, Bridge F5.7 was a 238-foot timber trestle comprised of seventeen 14-foot spans to cross Placer Creek.

ARRC has initiated a progressive bridge modernization program to prepare for the future. Design and material emphasis is on durable, low maintenance, long service life structures that can be installed with minimal interruption to train operations. These replacement bridges are often steel or concrete ballast deck with steel piles. They are less expensive and have a longer life cycle, better safety performance, and less environmental impact than timber trestle bridges. For example, Bridge F5.7 was replaced in 2006-2007 with a new steel bridge.

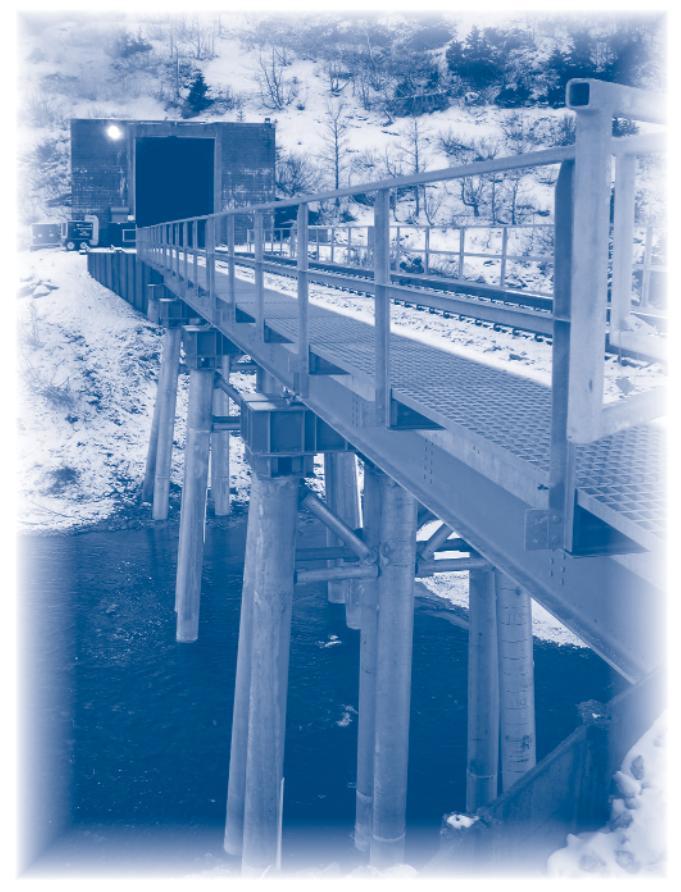
A steel bridge replaced the timber bridge at mile F5.7 in late 2006.

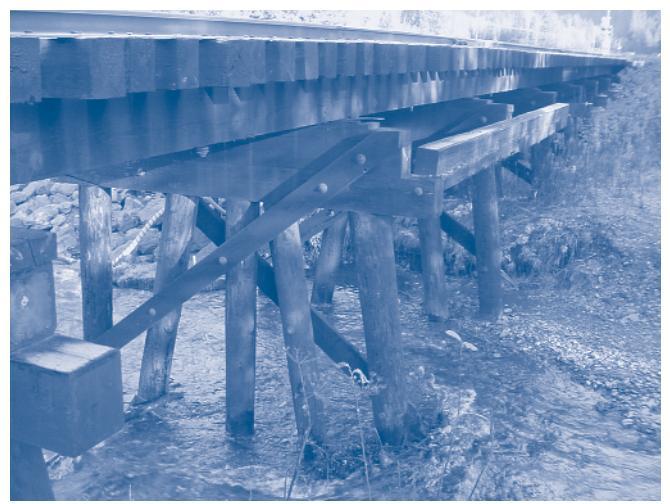
Bridge 6.60 is a 135-foot timber trestle with nine 15-foot spans. It crosses Bear Creek near Seward. Originally built in 1917, Bridge 6.6 was rebuilt in 1953, and most components were replaced in 1985.

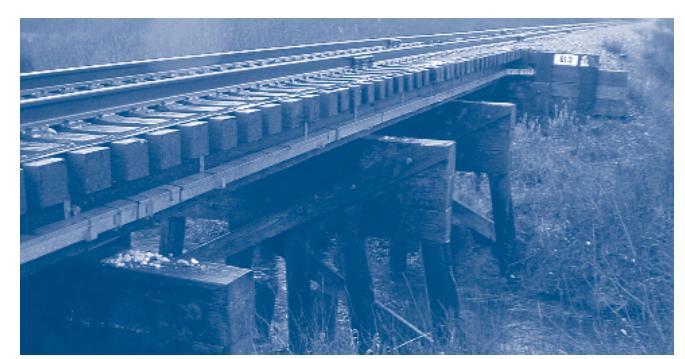
Bridge 61.3 is a 54-foot timber trestle comprised of two 15-foot, one 14foot and one 10-foot spans. It crosses a Placer River tributary near Portage. Originally constructed in 1919, it was rebuilt in 1950, and many components have been replaced since then.

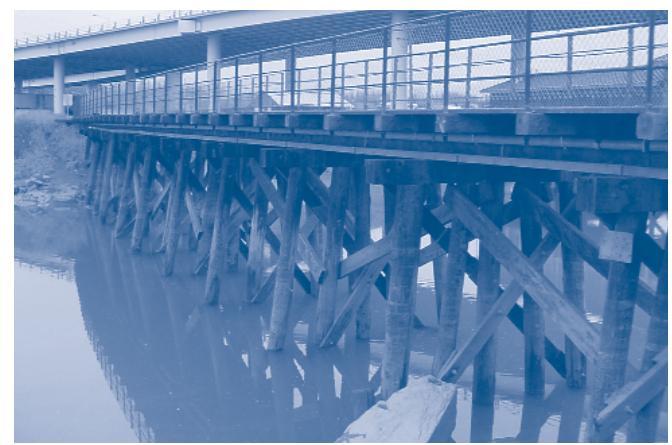
The Ship Creek Pedestrian Bridge at mile 114.6 is in the Anchorage Rail Yard. Originally built in 1916 as a 196-foot bridge comprised of fourteen 14-foot spans, it was rebuilt in 1938 and 1956. Bridge 114.6 was removed from train service in 1987, when it was converted to pedestrian use only.

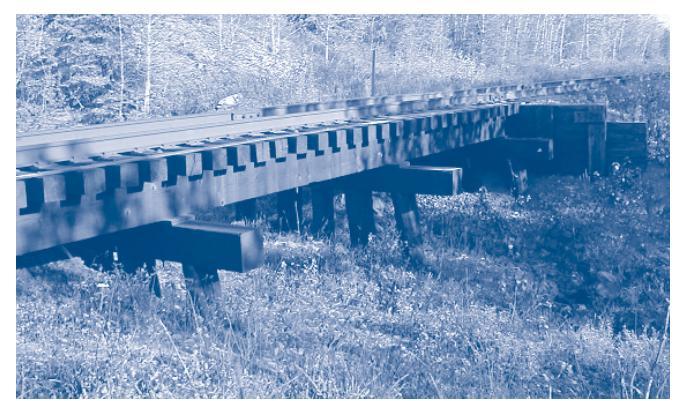
Bridge 337.0 is a 42-foot timber trestle with three14-foot spans. It crosses a Nenana River drainage eight miles south of Denali Park. Originally built in 1922, it was rebuilt in 1948 and many components have been replaced since then. (2004 ARRC Bridge Survey photos)
